**THE EFFECT OF ENGINEERING PARAMETERS ON THE FRETTING
BEHAVIOUR OF MORSE TAPERS UNDER CYCLIC LOAD**

**Debra L. Young
Department of Mechanical Engineering
McGill University
Montreal, Quebec, Canada**

**A Thesis submitted to the
Faculty of Graduate Studies and Research
in partial fulfillment of the requirements
of the degree of
Master of Engineering (MEng)**

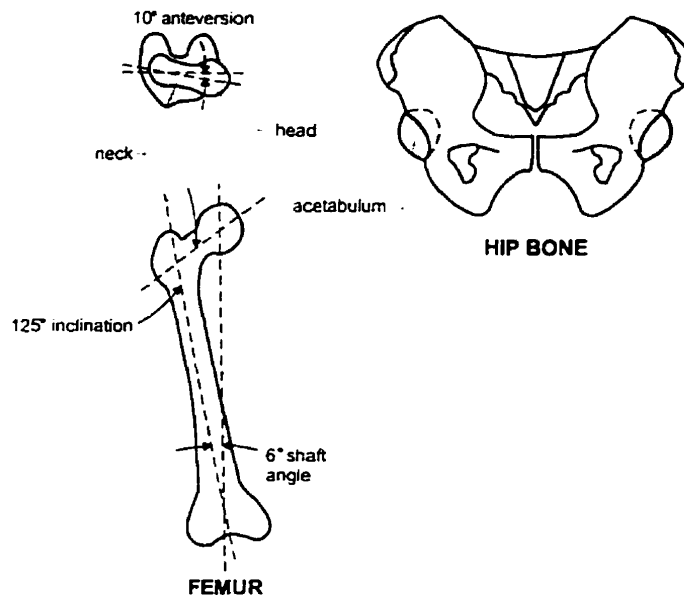
FIGURE 1.1 Schematic of the femur and hip bone. The hip joint is the articulation of the head of the femur and the acetabulum of the hip bone.

The hip joint is the articulation of the proximal femur and the innominate bone (hip bone) (Figure 1.1). Extending from the femoral shaft, at about 125° of inclination and 10° of anteversion, are the neck and head of the femur. Apposition of the latter with the acetabulum (the cup-like recess in the innominate bone) is maintained by a cylindrical encasement of multi-directional fibres and intrinsic ligaments called the articular capsule. The head, neck, and acetabulum are all composed of a very porous trabecular network of bone mass referred to as cancellous or spongy bone, strengthened by a thin, hard shell of compact or cortical bone. Smooth motion of the joint is facilitated by the low frictional properties of hyaline cartilage (coefficient of friction $[\mu] = 0.002$)¹ which partially covers the surfaces of the apposing bone segments. The medullary canal refers to the hollow cavity of the tubular femoral shaft which consists primarily of compact bone.^{2,3,4}

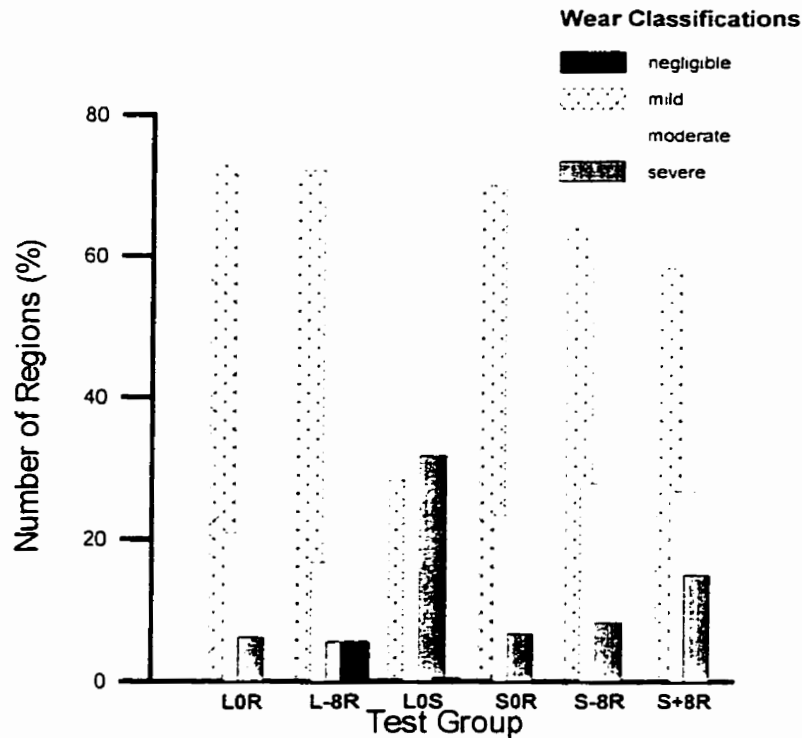
FIGURE 4.4 Results of qualitative analysis. Each bar represents the total number of zones given a specific wear classification for the particular test group.

of wear particularly at the extreme tip and base of the contact area. The graph in Figure 4.4, which shows the percentage of total zones given a specific classification, indicates that the smooth tapers (LOS) had a greater number of zones exhibiting moderate and severe wear compared to all other test groups, and that the small tapers (SOR, S-8R, S+8R) had slightly more zones in which moderate and severe wear were observed compared to the large tapers (LOR and L-8R). Chi-squared tests for comparing proportions were performed on the data for each wear classification, excluding data for the smooth tapers since their classifications were not equivalent to those for rough tapers. There was no statistically significant difference between 0 mismatched versus $\pm 8'$ mismatched tapers, or between large versus small tapers, for any of the wear classifications.

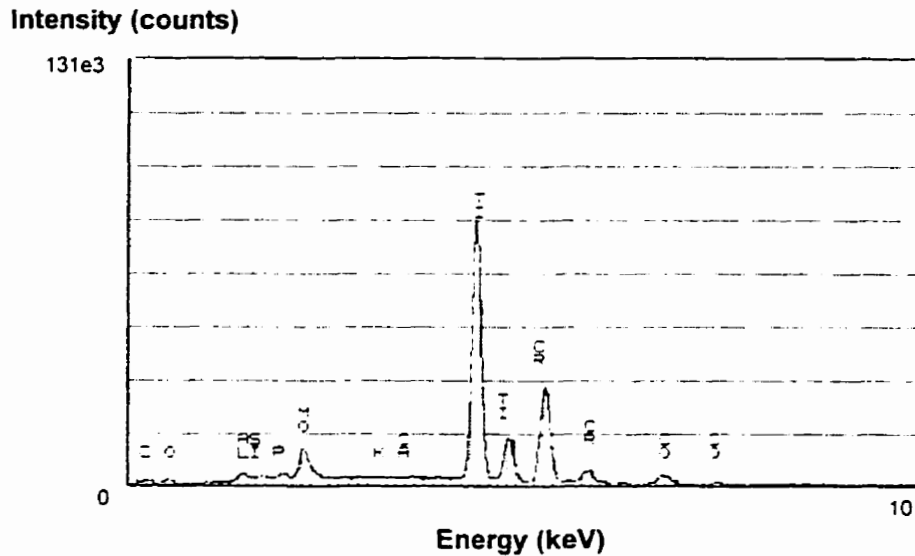
FIGURE 4.7 X-ray spectrum taken from black deposits observed on S+8R male taper.

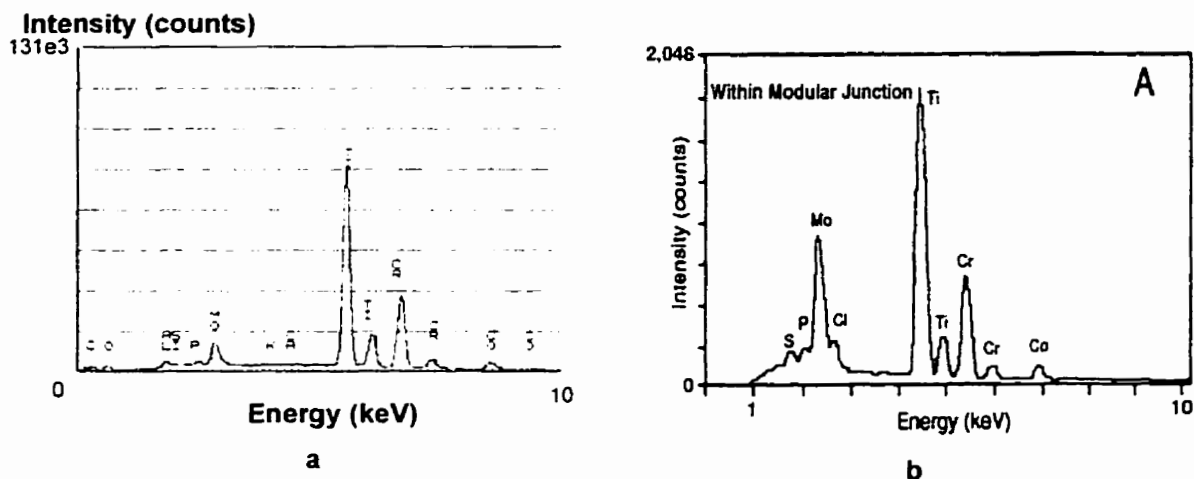
FIGURE 5.2 a X-ray spectrum taken from black deposits observed on S+8R male taper of current study. b X-ray spectrum of a black corrosion deposit taken from the modular junction of a retrieved implant. (Reproduced from reference 52)

obtained from these laminae (Figure 5.2a) were comparable to spectra reported by Urban et al.⁵² which were obtained from mixed oxides within the taper junction of retrieved specimens (Figure 5.2b). In the same study Urban also identified Co and Cr chlorides within the junction, and orthophosphate at the base of the contact junction, however, only one spectrum obtained in this study had a discernible Cl peak, and only small P peaks were seen on a few spectra.
